Control of rain water run off during the construction of cross country pipelines

In March 2006 National Grid began constructing a pipeline stretching 316km from Milford Haven on the Welsh coast, to Tirley in Gloucestershire, with a planned completion date of October 2007. Due to the size of the project, deadlines are tight, and agreements were made with the authorities that some winter working would be take place. This is unusual since cross country pipelines are normally only constructed during the drier months of March to October.

I joined the Milford Haven pipeline project in November 2006 as a Project Engineer working with the Environment team on site. It was immediately clear that the biggest challenge the team were facing was based around the wet weather conditions during winter working. It has been part of my role to help communicate the importance of implementing and maintaining winter working mitigation measures to the construction teams and senior managers on the project.

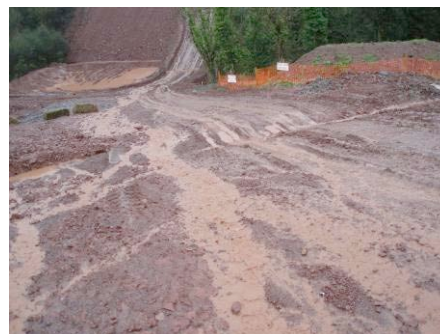
During heavy rainfall streams of water known as “run off” may flow down the spread. As the run off flows down hill, it picks up soil particles which will be deposited in ditches and watercourses if not controlled. Allowing silt laden run off to enter a watercourse is pollution. The Environment Agency police

watercourses, and if they suspect that more than 35mg/litre of suspended solids are entering a watercourse they could take samples and potentially prosecute under the Water Resources Act 1991. This could lead to fines of up to £20,000 or a custodial sentence of 2 years.

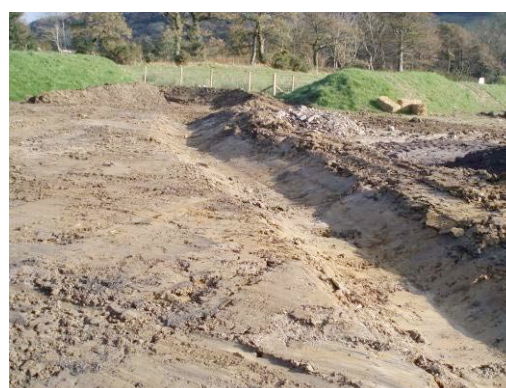
On sloping ground grips and sumps were installed across the spread. Grips are open drains which capture run off, directing it off the spread into sumps. A berm of soil can be installed behind the grip to make it more robust. Sumps act as a settling device, and whilst water is

retained in sumps any sediment drops out of the water column. From the sump the water slowly seeps out into vegetation on the side of the spread

where it is naturally filtered as it flows down hill. The sump should be surrounded by straw bales and geotextile to prevent the water forming fast flowing streams if it over flows the sump pit. Straw bales capture the water, and filter it through onto the surrounding ground where it will seep away slowly.
